Manhole Inspection Summary

Manhole # S21AA_008MH

Location Address: **1712 PARKER CT**

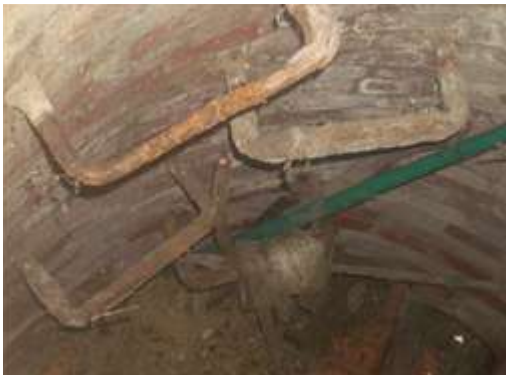
Defect 3

Count: **5** Missing: **0** ☒ **Corroded**

☒ **Evidence Of Surcharge** Depth: **3** (ft.) ☐ Active Surcharge Present

CORRODED STEPS WITH
SURCHARGE EVIDENCE

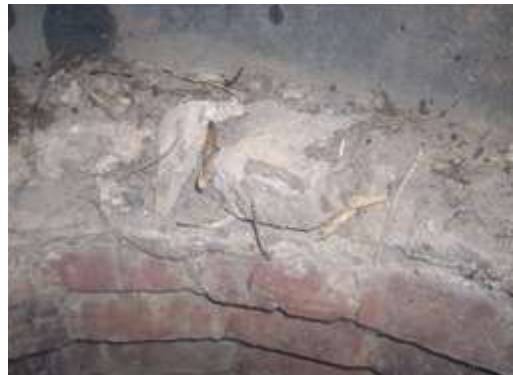
Defect 2

Condition: ☐ Sound ☐ Cracked ☐ Root Intrusion ☐ Loose Brick ☒ **Deteriorated**

DETERIORATED CORBEL

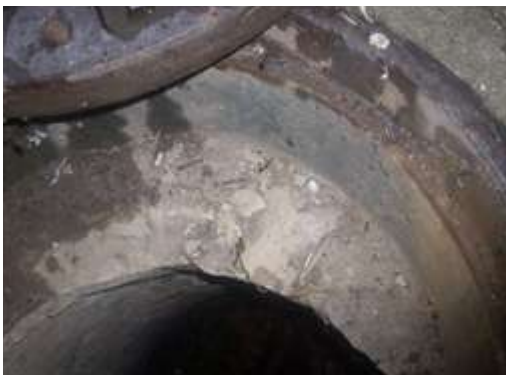
Defect 1

Offset: **4** (in.)

FRAME OFFSET

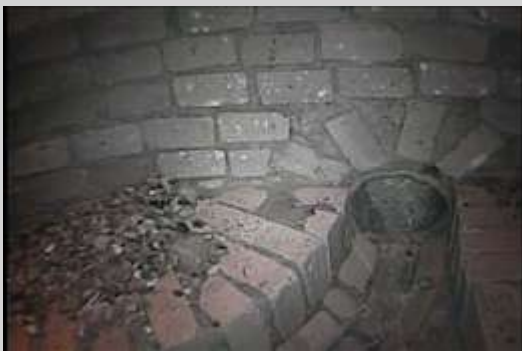
3 O'Clock Inflow

Pipe Height: **6** (in.) Rod and Bar (Angled)
Pipe Material: **Clay** ☐ Pipe Lined
Invert Depth: **8.80** (ft.) Flow Characteristics: **None**
Deposits: ☐ None ☒ **Mud** ☐ Sludge ☐ Debris ☐ Grease
Silt Depth: **2** (in.) Deposits Extent: **Light**
Infiltration: **None** Pipe Seal Cond: **Sound**
